# Manhole Inspection Summary

Manhole # S33SS\_028MH

Insp Date: **4/19/07 11:45 AM**

**Location** Address: **2601 CHARLES ST**

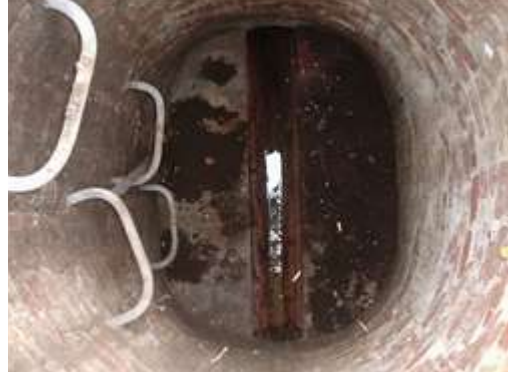
Top View

Evidence of surcharge - Bench debris.

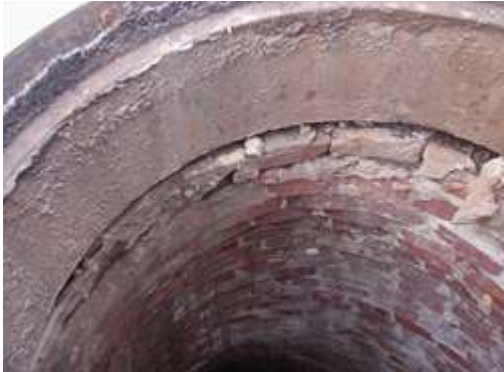
Defect

Frame leaks. Adjustment deterioration, loose brick and infiltration. Corbel and Barrel infiltration - other side.

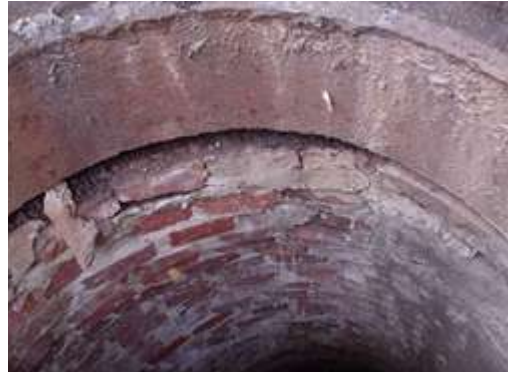
Defect

Frame leaks. Adjustment deterioration, loose brick and infiltration. Corbel and Barrel infiltration.

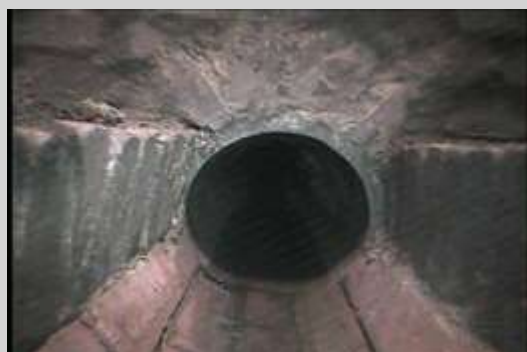
Pipe Out @ 12 O'Clock

Infiltration: **Evidence** Pipe Seal Cond: **Unknown**

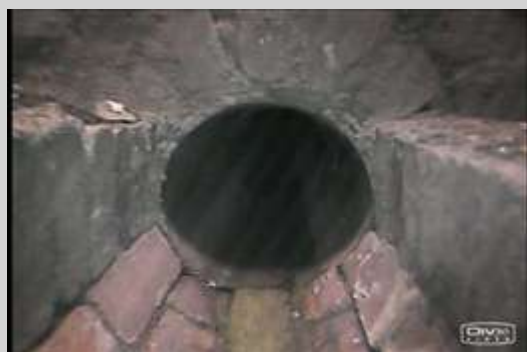
Drop In @ 6 O'Clock

Channel deterioration.
